# Workshop bulletin: Commercial Vehicle Flywheels

### COMMERCIAL VEHICLE FLYWHEELS – FUNCTION AND DAMAGE PATTERNS

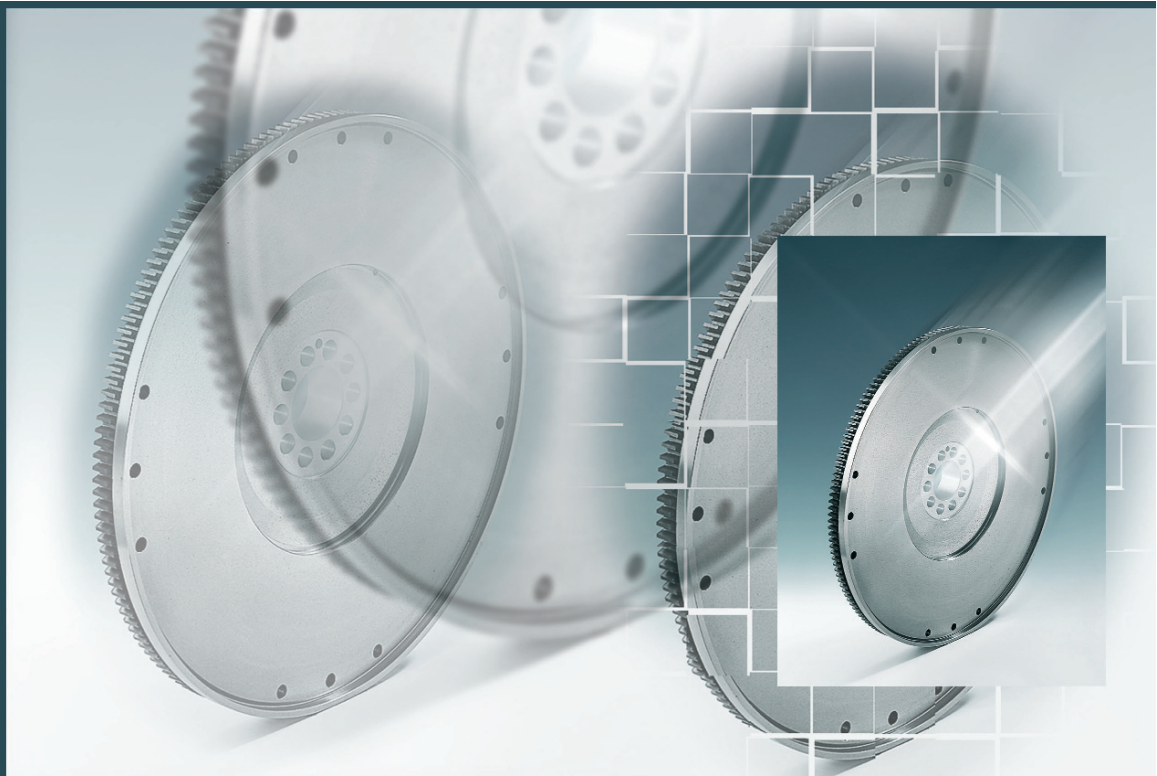
The flywheel is the coupling link between the engine and the clutch system and as such performs several tasks: owing to their design, internal combustion engines run uneven. Few cylinders and low rpm amplify the effect. Commercial vehicles generally operate at low engine speeds or run idle for a prolonged period of time. The flywheel is able to outbalance uneven running characteristics. It is bolted to the crankshaft and its mass yields a more even running of the engine. In addition, the flywheel, which is made from highgrade grey cast iron, supports the clutch and, together with the clutch pressure plate, acts as the clutch disk's friction partner. A centering rim or centering pins guarantee the precise alignment of the clutch. When cranking the engine, the pinion of the starter engages with the ring gear which is shrunk on the outer circumference of the flywheel. The flywheel centre carries the pilot bearing which supports the transmission input shaft.

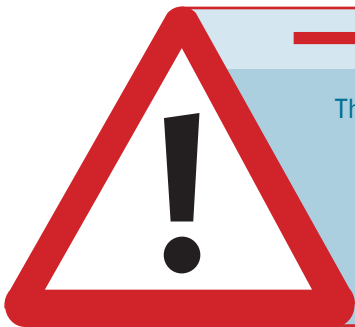
The proper functioning of a newly installed clutch is not guaranteed, unless the flywheel is replaced or at least resurfaced thoroughly. Here, it is essential not only to observe the specified tolerance values, but also to re-machine the bolting surface equally to the running surface. The flywheel thickness must never exceed the minimum value specified by the manufacturer.

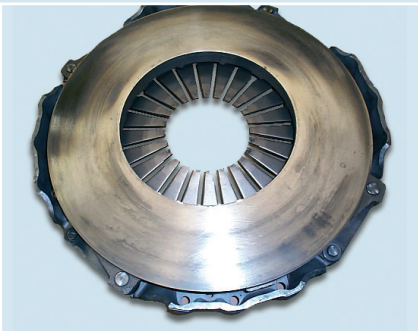
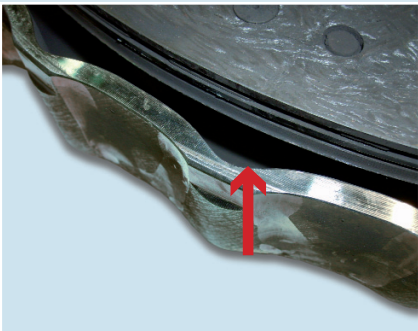
1. Grooves and scores in the centering device (clutch cover centring)

The clutch is not centred on the centring rim prior to tightening the bolts. As a result, the clutch pressure is jammed and no parallel engagement is possible between clutch pressure plate, clutch disk and flywheel. The clutch disk starts to slip, localized heat is generated and hot spots occur on the flywheel. This can lead to the “vitrification” of the friction material. The inaccurate installation can also lead to clutch judder and clutch disengagement problems. Therefore, the flywheel must be replaced or at least resurfaced; the clutch pressure plate and disk must be replaced.

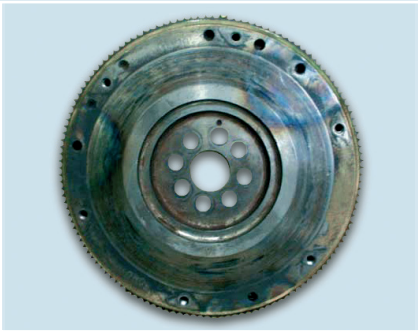
2. Flywheel damaged by heat / discoloured blue; hot spots, thermal cracks

This damage pattern can result from a worn clutch, driver-induced clutch slip, start-off in high gear or from an ill-adjusted release system. Another cause could be contamination by oil or grease resulting from a defective shaft seal ring or an excessively greased profile shaft. The flywheel must be replaced. It is imperative to install a new pilot bearing. The clutch pressure plate and disk must be replaced. If the defect is due to excessive/contaminated oil or grease, it is also necessary to clean the clutch housing as well as the shaft seal rings on both the engine and transmission side.

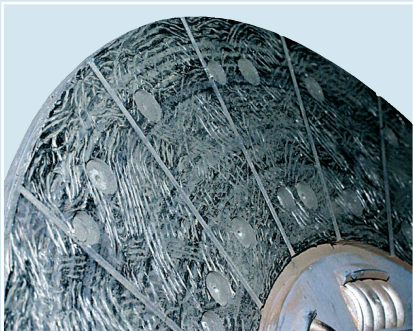
3. Scores in the clutch lining on the flywheel side

The flywheel was not replaced or resurfaced when the clutch was replaced. The flywheel surface shows hot spots and is warped. The flywheel must be replaced or at least resurfaced; the clutch disk must be replaced. Also refer to damage pattern “Reflective surface, scores, thermal cracks”.

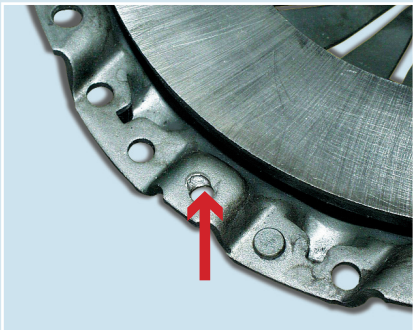
4. Misalignment of the centering pin/s, centering bores

Failure to centre the clutch prior to tightening it causes a deformation of the centring pin and clutch cover. In this case, the flywheel and the clutch must be replaced.

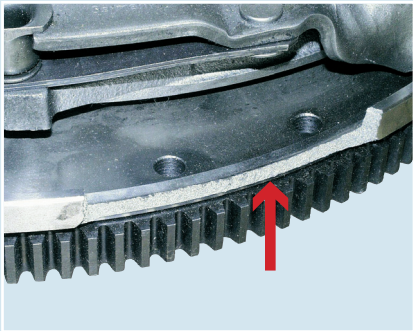
5. Centering ring partially worn out

Improper handling is the likely cause of this damage pattern (the flywheel may have been dropped). Perhaps the clutch was installed out-of-centre, there may be contaminants or burrs on the centring rim or the clutch was not tightened crosswise. It could also be that the flywheel is distorted. In any of these cases the flywheel must be replaced. It is also recommended to replace the clutch, as the clutch cover can be distorted

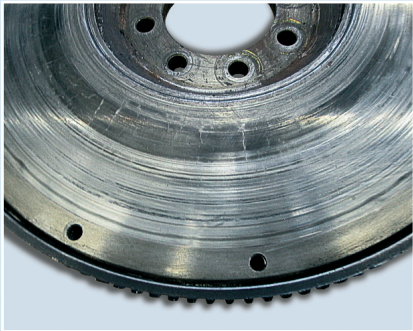
6. Reflective surface, scores, thermal cracks

This damage signals excessive thermal load caused by worn friction linings, a defective clutch actuation system or handling error. The flywheel must be resurfaced or replaced, and the clutch disk inspected – as described in the section “Scores in the clutch lining on the flywheel side”.
